**The Seawall Subcommittee
SLR and Storm Surge in Watch Hill
4:00 PM, February 11, 2021 via Zoom
The WH Harbor Seawall: History and Future
Minutes**

THE SEAWALL SUBCOMMITTEE

Watch Hill Harbor Seawall: History and Future

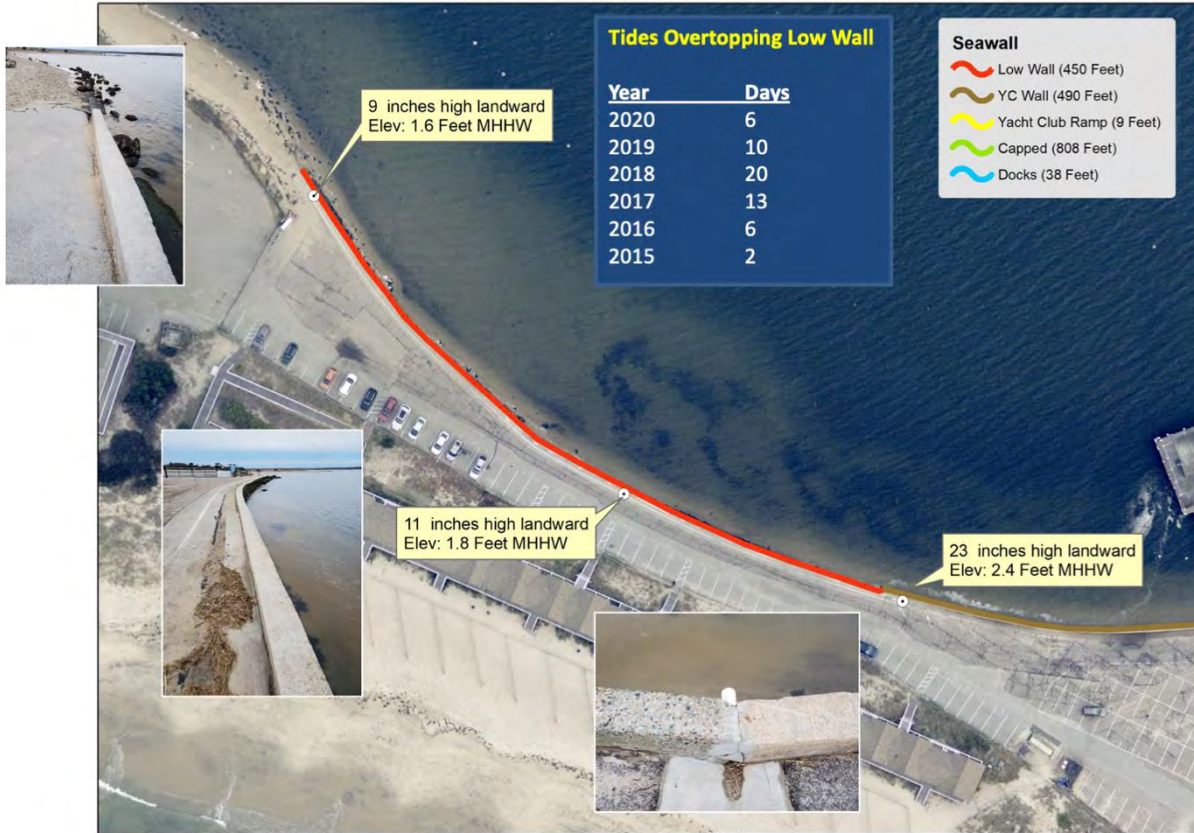
- Explained that the elevation (in feet MHHW) at top of wall and landward height is how many inches high off the roadbed
- Wall is low and is overtopped in Nor'Easters and very high tides as we have seen a few times the last weeks.
- They provided a table showing how many days each year the tide exceeded the Low Wall elevation
- Condition is poor
- No metal sheeting
- They explained the gunite coating and stone composition

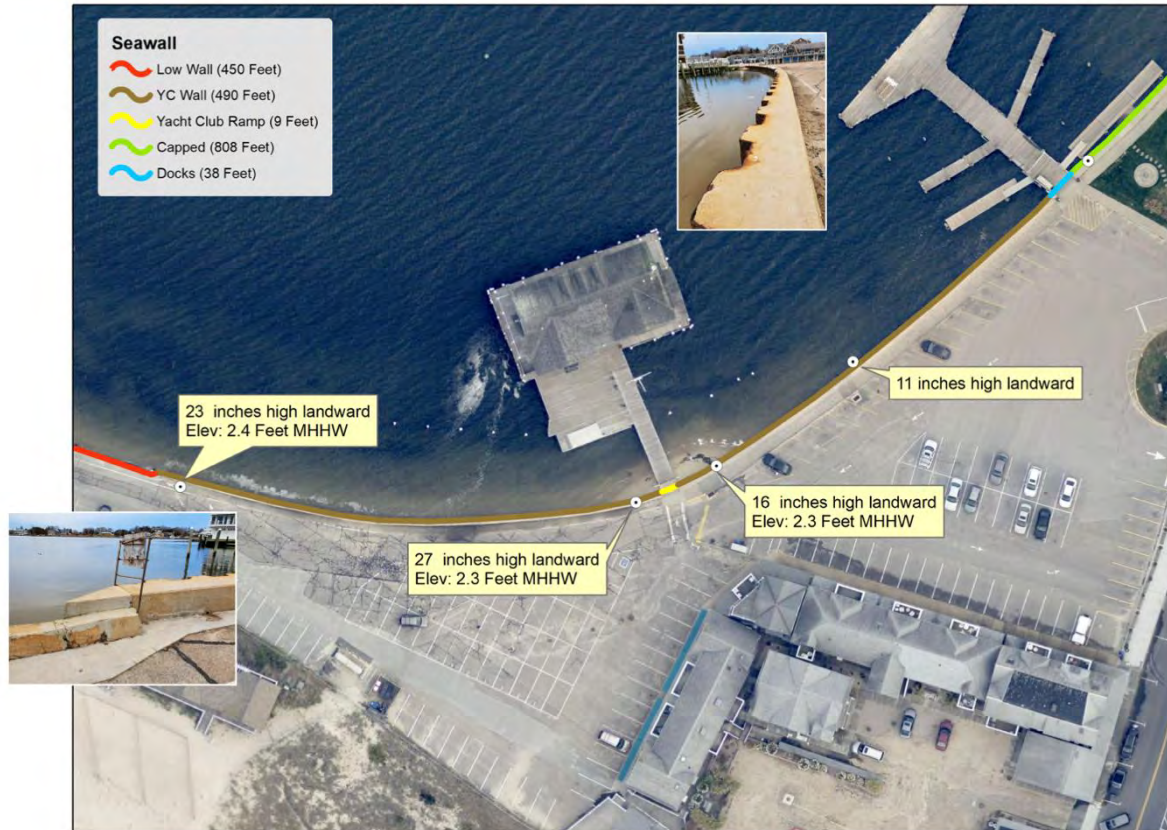
Yacht Club Wall

- Higher up
- Decent condition
- They pointed out the uncovered metal face
- They noted the jump in wall elevation at junction with Low Wall
- Explain sheet metal issue, cannot replace, current metal sheathing is a different design

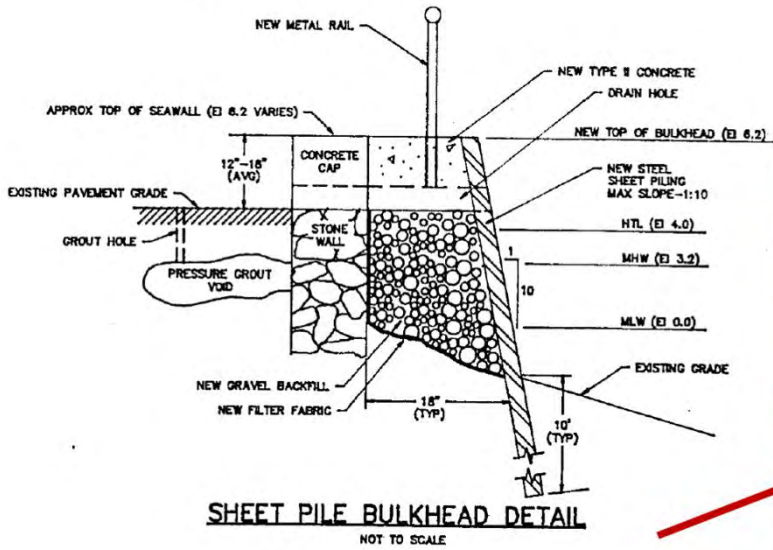
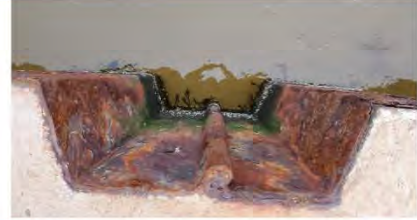
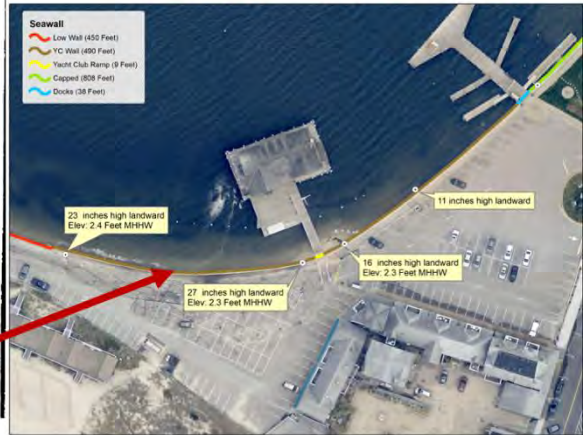
Yacht Club Wall

- Pointed out engineering diagram from the permit application
- Permit approved in 1987

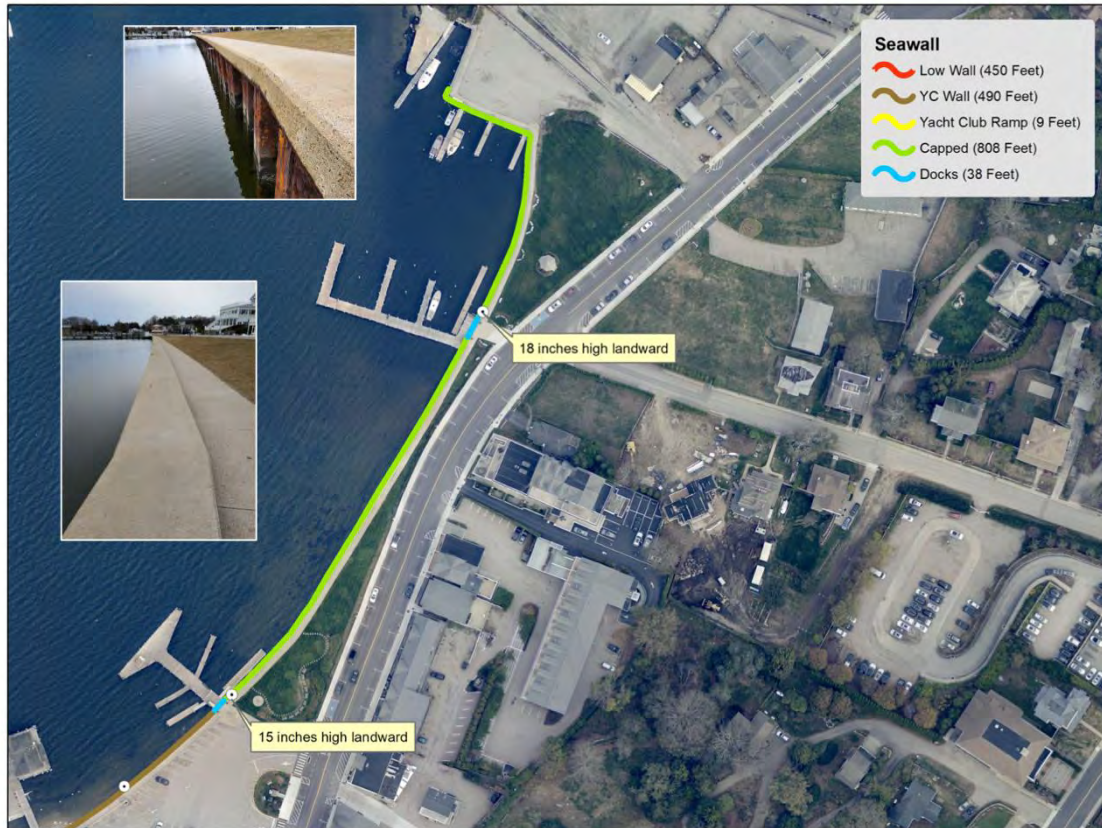
Capped

- In pretty good condition
- Pointed out metal sheet under cap
- Permit approved 1997

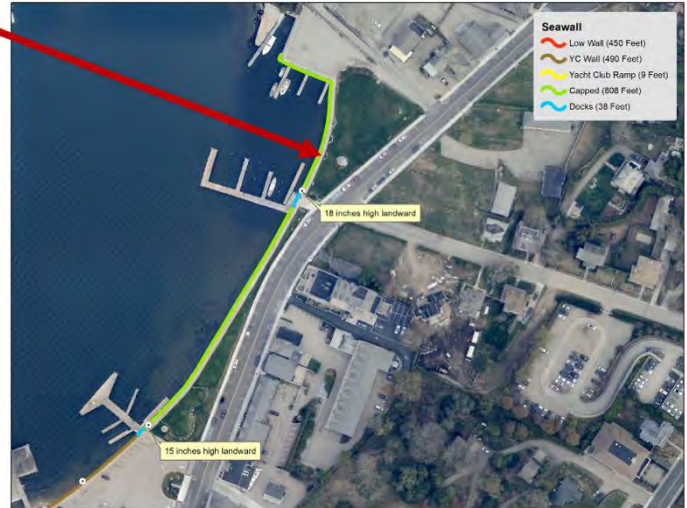
- Cap design is very clear in the engineering diagram

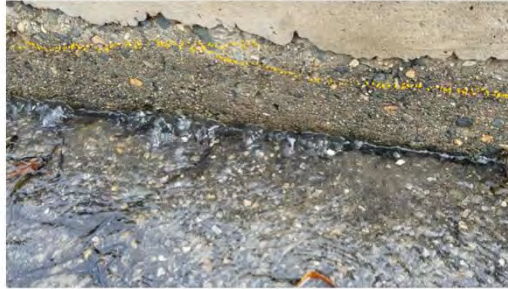
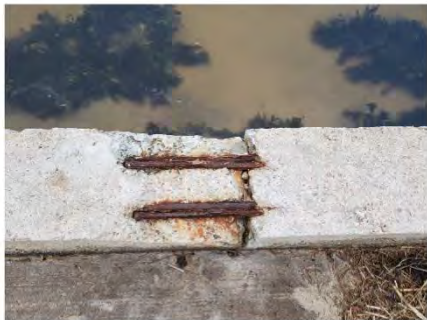
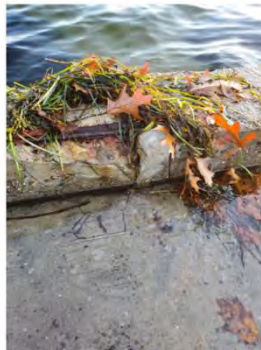
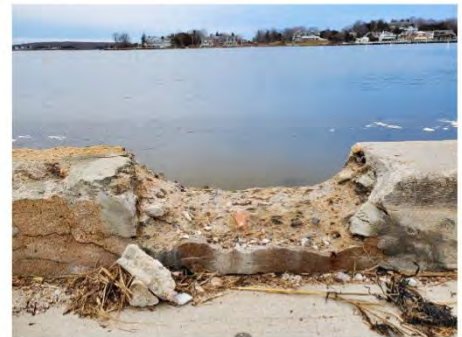
Seawall Condition

- Low Wall in poor condition. Too low now
- We already have flooding at low points
- They explained the need to have the roadbed and drains to allow drainage and stay above groundwater elevation

- Need more information on the design of the wall and the options we have to elevate it to accommodate 3-5 feet of SLR
- Grant and Beth Bean will continue search Fire District records for additional information
